Gully Erosion Stabilization in a Highly Erodible Kandiuistalf Soil at Pindorama, São Paulo State, Brazil

Maria teresa Vilela nogueira abdo (corresponding author: Polo Regional centro norte, aPta, saa, P.o. Box 24, 15-830.000 Pindorama, sP, Brazil, mtvilela@terra.com.br), sidney Rosa Vieira (iac), antonio lucio Mello Martins (Polo Regional centro norte, aPta) and luis cláudio Paterno silveira (lavras University, UFla).

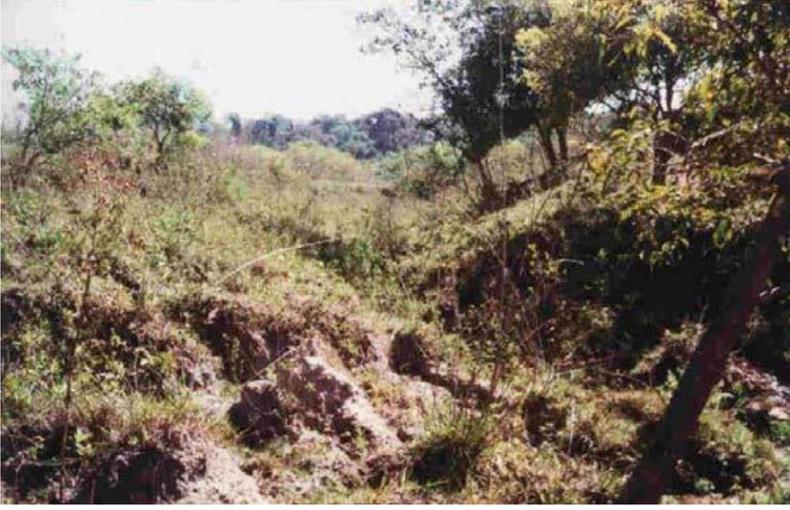
Figure 1. Gully erosion before restoration in 1997, Polo Regional Centro Norte, APTA, Pindorama, SP, Brazil.

The soils of Polo Centro Norte, Pindorama, SP, Brazil are classified as Kandiuistalf. These soils have a sandy texture in the surface layer (A horizon) and clay loam in the subsurface layer (B horizon). This difference in the texture of soil horizons makes them highly susceptible to erosion processes due to differentiation of water infiltration velocity in the different horizons (Lepsch and Valadares 1976, Embrapa Solos 1999). This susceptibility to erosion was aggravated by inadequate management of the area, which for decades had been used as pasture with no soil conservation practices. For example, a coffee crop planted downhill, without enough conservation measures such as contours and vegetation between rows, had very low production and was soon transformed into pasture after degradation. Excess runoff has also increased the depth of cattle tracks towards the water in the lower part of the area. As a result of these degradation processes, a gully formed approximately 700 meters long and in some places up to 15 meters deep (Figure 1). Before 1997, large amounts of soil and sediment flowed down the eroded gully and into lower drainage channels.

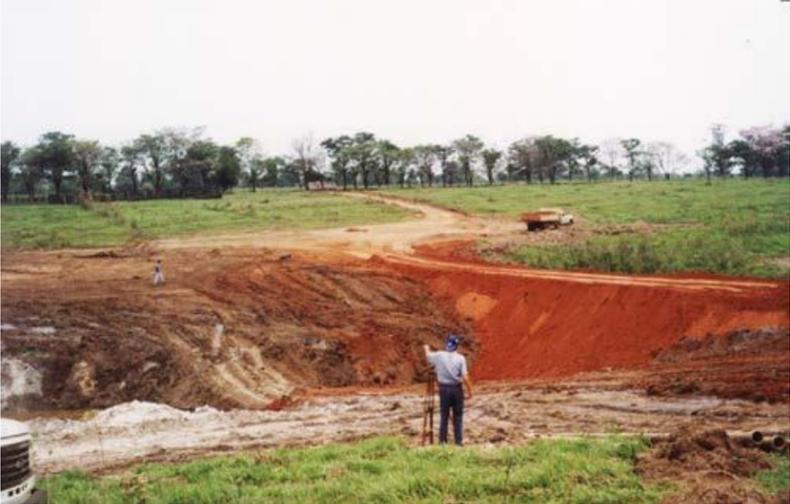
Figure 2. Dam construction, 1998, Polo Regional Centro Norte, APTA, Pindorama, SP, Brazil.

This material was originated from a B horizon layer, clay soil, and it was placed in 20–30cm layers. Each layer was compacted manually or with pressure equipment pulled by a tractor. When a layer was fully compressed, a new layer was poured, and so on until the desired height of the dam was reached (Figure 2). To enable the free running of excess

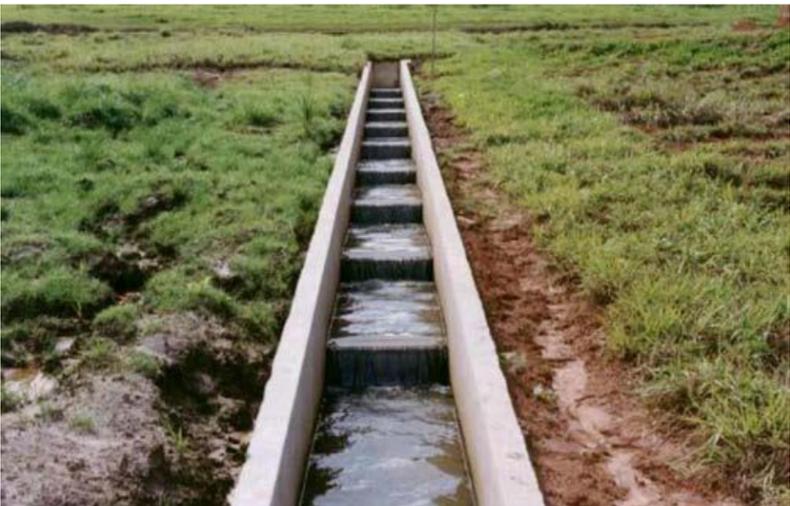
Figure 3. Concrete spillway channels to allow excess water flow between ponds.

water flow, concrete spillways channels were constructed to minimize dam wall erosion under storm conditions and uncontrolled runoff (Figure 3).

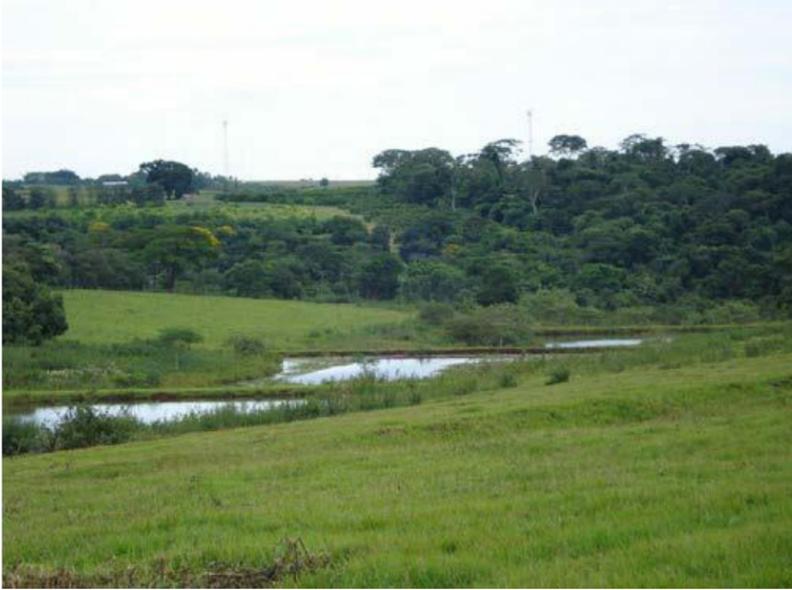
Figure 4. View of the dams in 2011, Polo Regional Centro Norte, Pindorama, SP, Brazil.

After the construction, the sides of the dams were covered with grass, *Paspalum notatum*. The surrounding area was also covered with grass to avoid erosion, which could compromise the investments done as well all the stabilization work (Figure 4). Additionally, the agricultural experimentation area located above the gully was maintained with continuous vegetation cover to avoid soil erosion and cattle and horses were removed from the neighboring area to avoid grazing by the water and to preserve native vegetation.

Thirteen years after the beginning of the project, the stabilization/rehabilitation process can be considered successful, offering farmers a solution to gully erosion problems, minimizing their loss of soil, and returning the land to a productive state (Figure 4). Currently, further restoration is being done with reforestation of native tree species and an agroforestry system in the edges of the ponds (Figure 5). The planting started in April 2011 and is under preliminary evaluation.

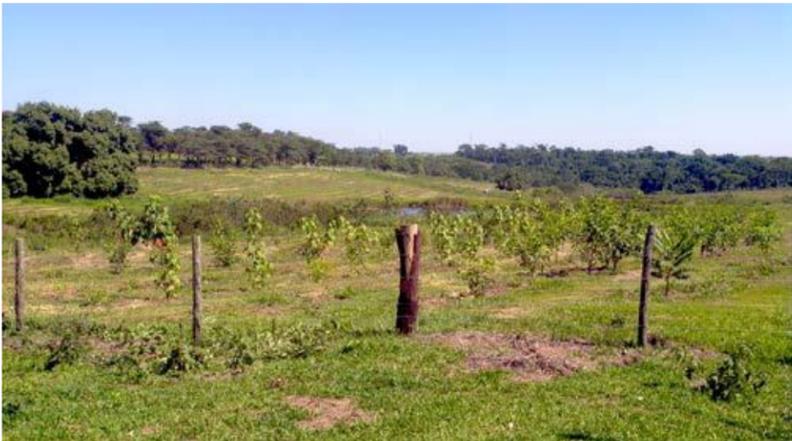
Figure 5. Reforestation and agroforestry system in the edges of the ponds for vegetation cover restoration.
